U.S. Air Force Airfield Damage Repair (ADR) Modernization Program

Moisture Detection of Stored Rapid-Setting Cementitious Materials

July 2018

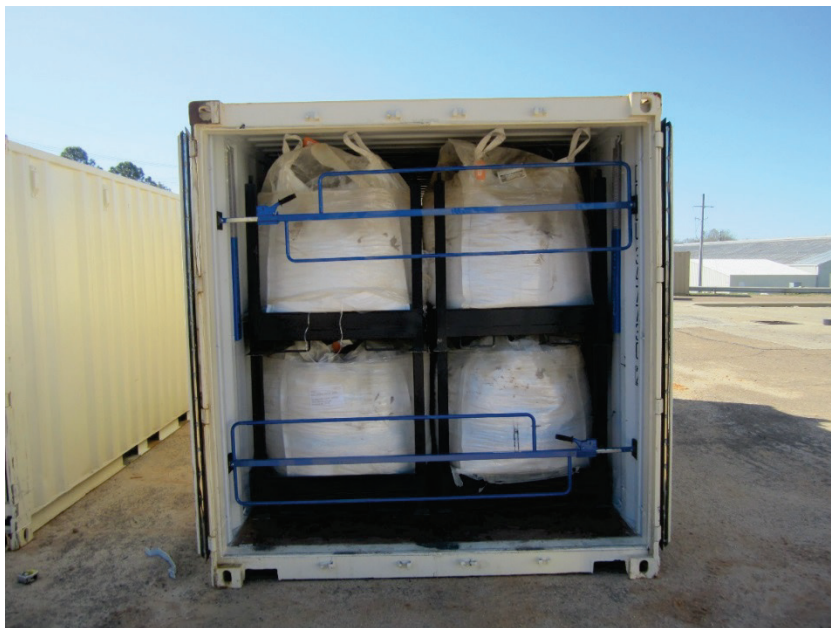
Figure 1. Conex container with Super Sacks in racks.

In order to assess the feasibility of long-term storage in a conex environment, a study was conducted to measure the internal temperature and humidity of the conex containers. Internal properties of four conex containers were measured over an approximate 3-month period. Of the four containers, three were fitted with moisture deterrent systems with a single container serving as a control. The four containers and moisture deterrents are listed in Table 1. Air temperature outside of the containers and rainfall data were also collected during the same time period. Illustrations of each of the moisture deterrents are shown in Figures 2 through 4.

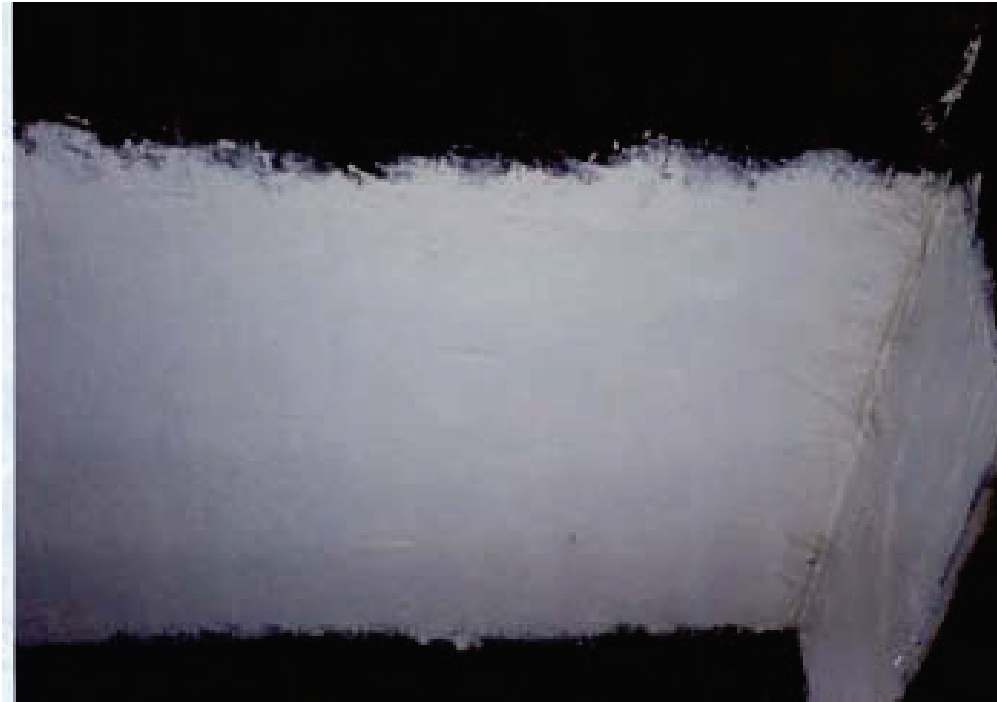
Figure 2. Kefa Airless 8125.

Kefa Airless 8125 is a water-based coating designed to store moisture during high humidity periods and release the moisture to be evaporated into the air during low humidity periods. This material can be applied by painting or spraying, is mold resistant, and was previously used by U.S. Army, Navy, and Coast Guard vessels.

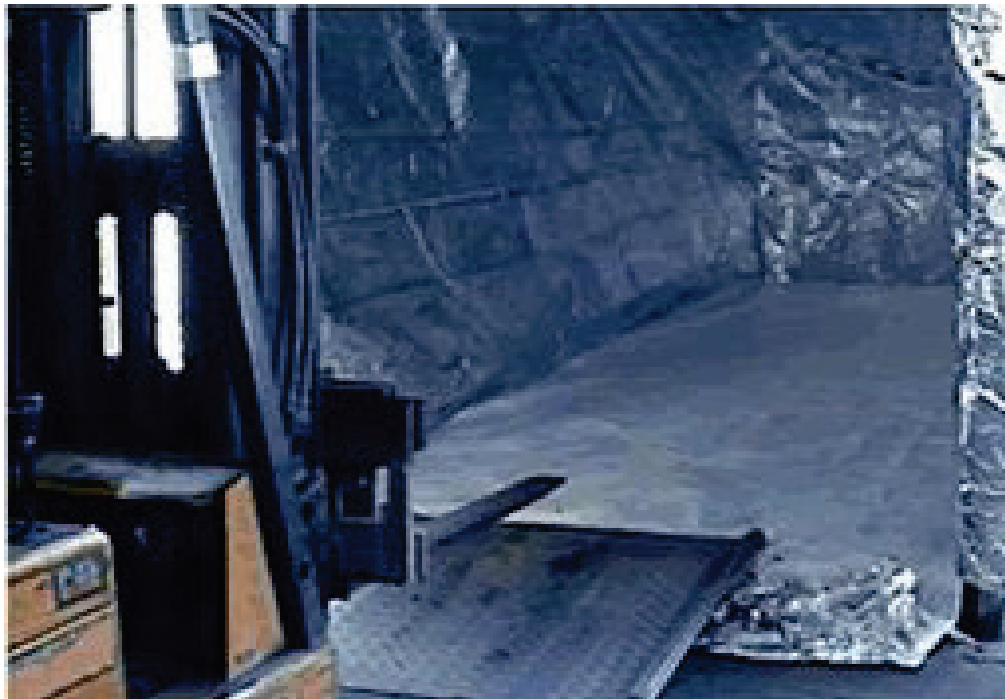
Figure 3. CorrPakBPS liner.

The aluminum foil liner is a reflective barrier material designed to create a temperature- and humidity-controlled environment. The liner is attached to the interior of the conex and can be completely closed after the material is loaded. Absorpole is a calcium chloride desiccant that can absorb up to 2 liters of moisture and is designed for conex containers.

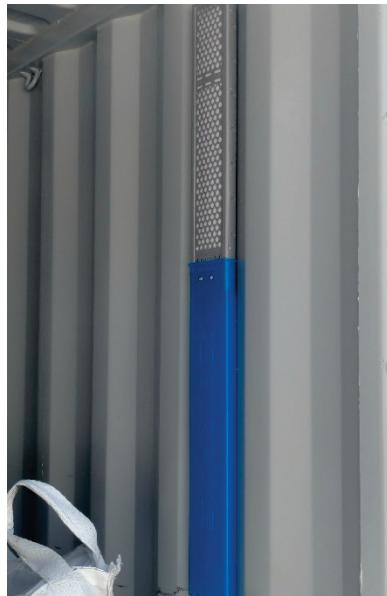
Figure 4. Absorpole.

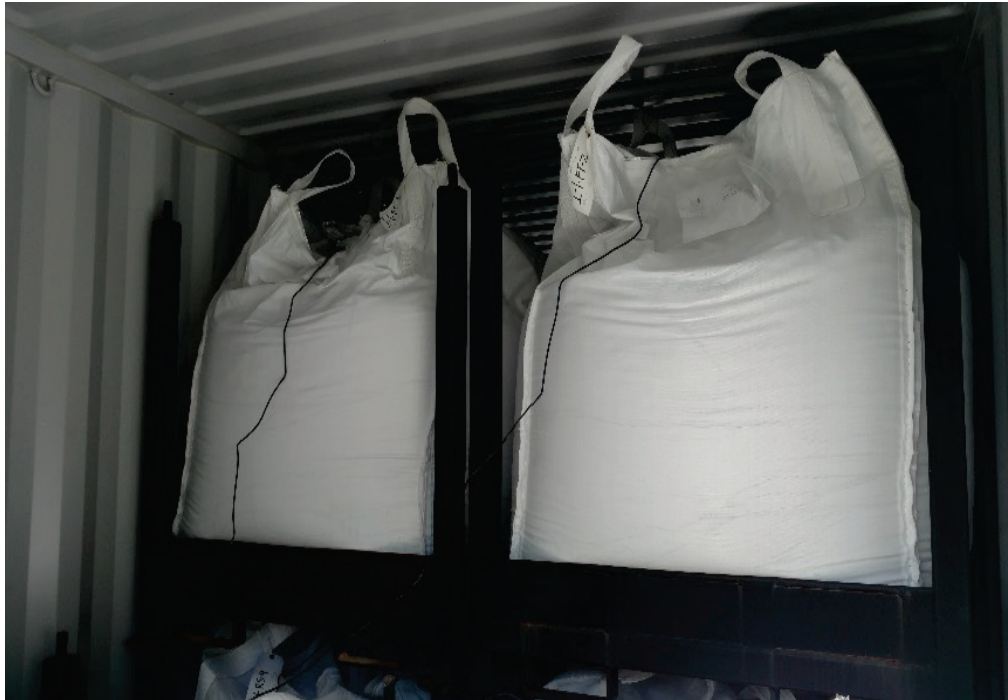
Figure 5. Sensor 1.

a. Sensor 1 embedded in Super Sacks.

Two different types of sensors were used: a typical soil moisture sensor and an RFID moisture sensor. The typical soil moisture sensor (hereafter referred to as sensor 1) was an Onset soil moisture probe connected to a HOBO data logger. This type of sensor must be physically connected to a data collection device in order to function. To read the data, a computer must then be attached to the data collection device. Onset soil moisture probe sensors and the data logger are shown in Figure 5.

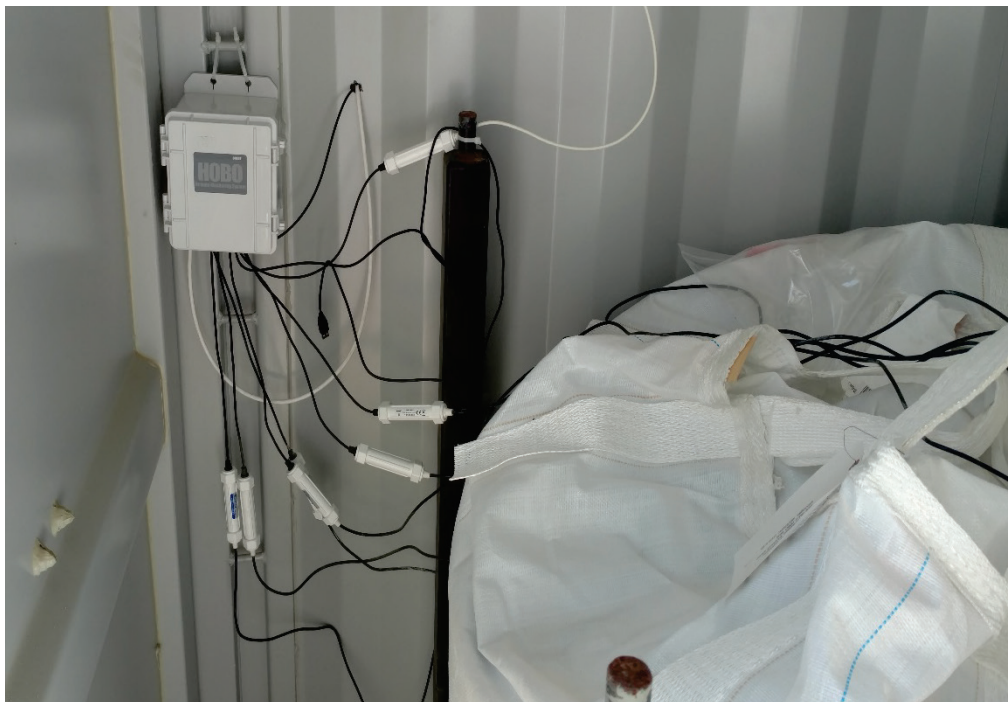
b. Cabling attached to logger device at end of conex.

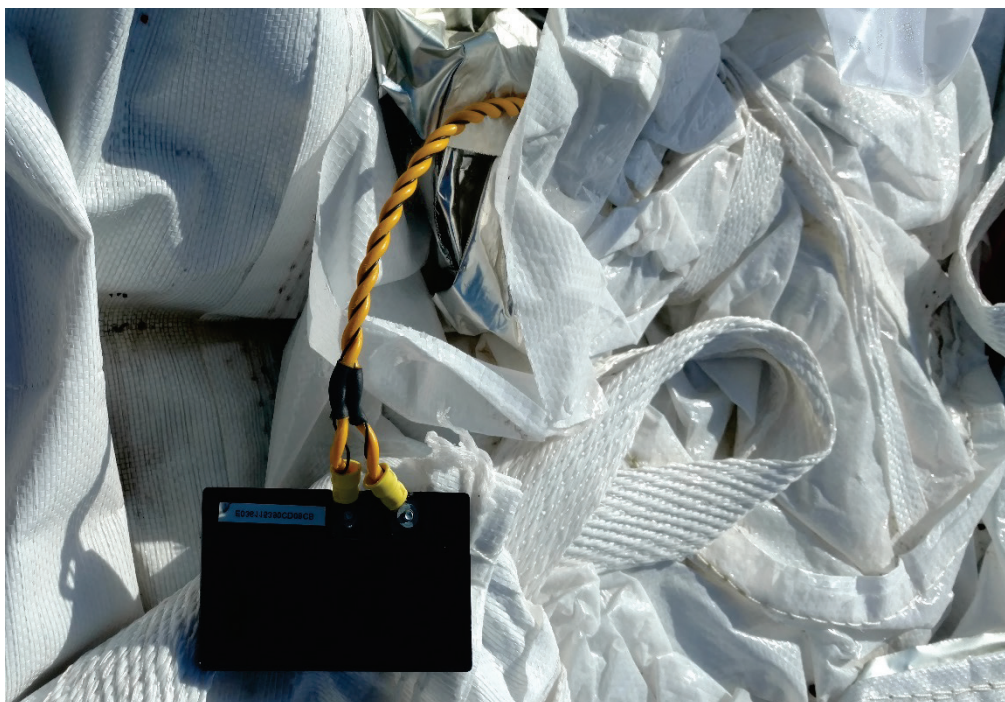
Figure 6. Sensor 2 with RFID transmitter.

The second type of sensor (hereafter referred to as sensor 2) is an RFID-type sensor that does not need to be physically connected to a logger in order to collect data. These sensors feature a leak-sense cable that can detect moisture throughout the length of the cable and an RFID transmitter. Cables were manufactured by Phase IV Engineering. The RFID transmitter allows the sensor to remain in the Super Sack, which can be moved freely, and measurements can be obtained by using a handheld or permanent stationed receiver.

Due to the nature of sensor 2, measurements consist of a true/false output that indicates whether a certain moisture threshold has been crossed at the time of measurement. Sensor 2 does not actually measure the amount of moisture present. Since the sensor is not connected physically, it has an internal built-in battery, which on longer tested regimens would have to be replaced periodically. The number of measurements obtained in a given time period significantly affects battery life. A sensor 2 cable with an RFID transmitter installed in a Super Sack is shown in Figure 6.

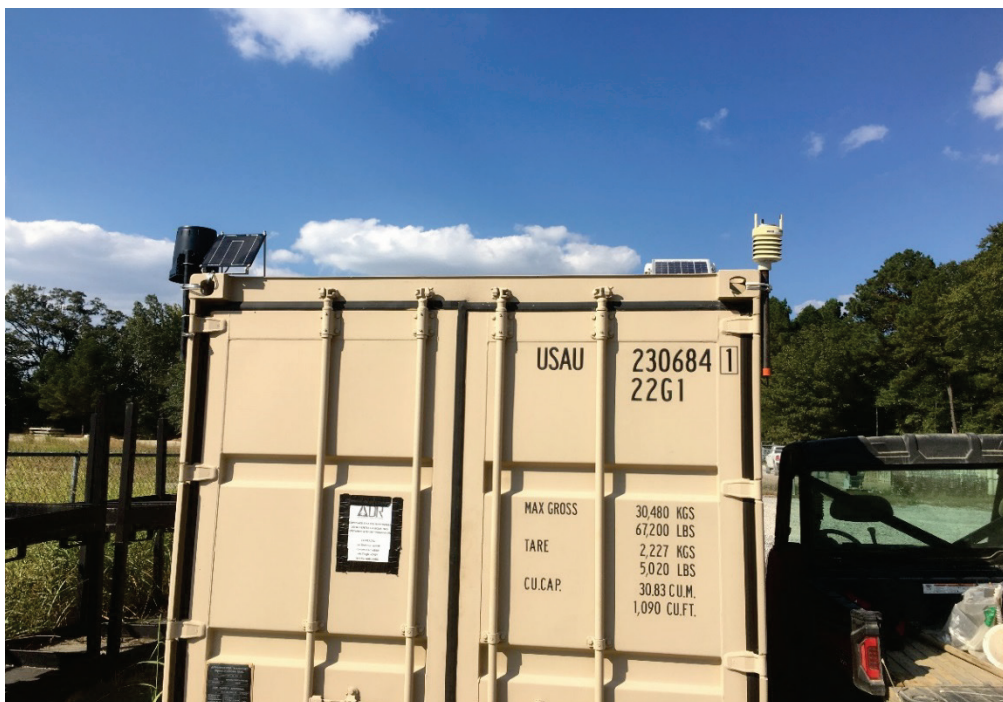
Figure 7. Conex closed with external weather monitoring devices attached.

identification (ID) was given based on four factors: inside conex or external (I or E), sensor type (1 or 2), material (RS or FF), and replicate number (1-3). Figure 7 shows the closed container with weather, temperature, and humidity monitoring devices attached.

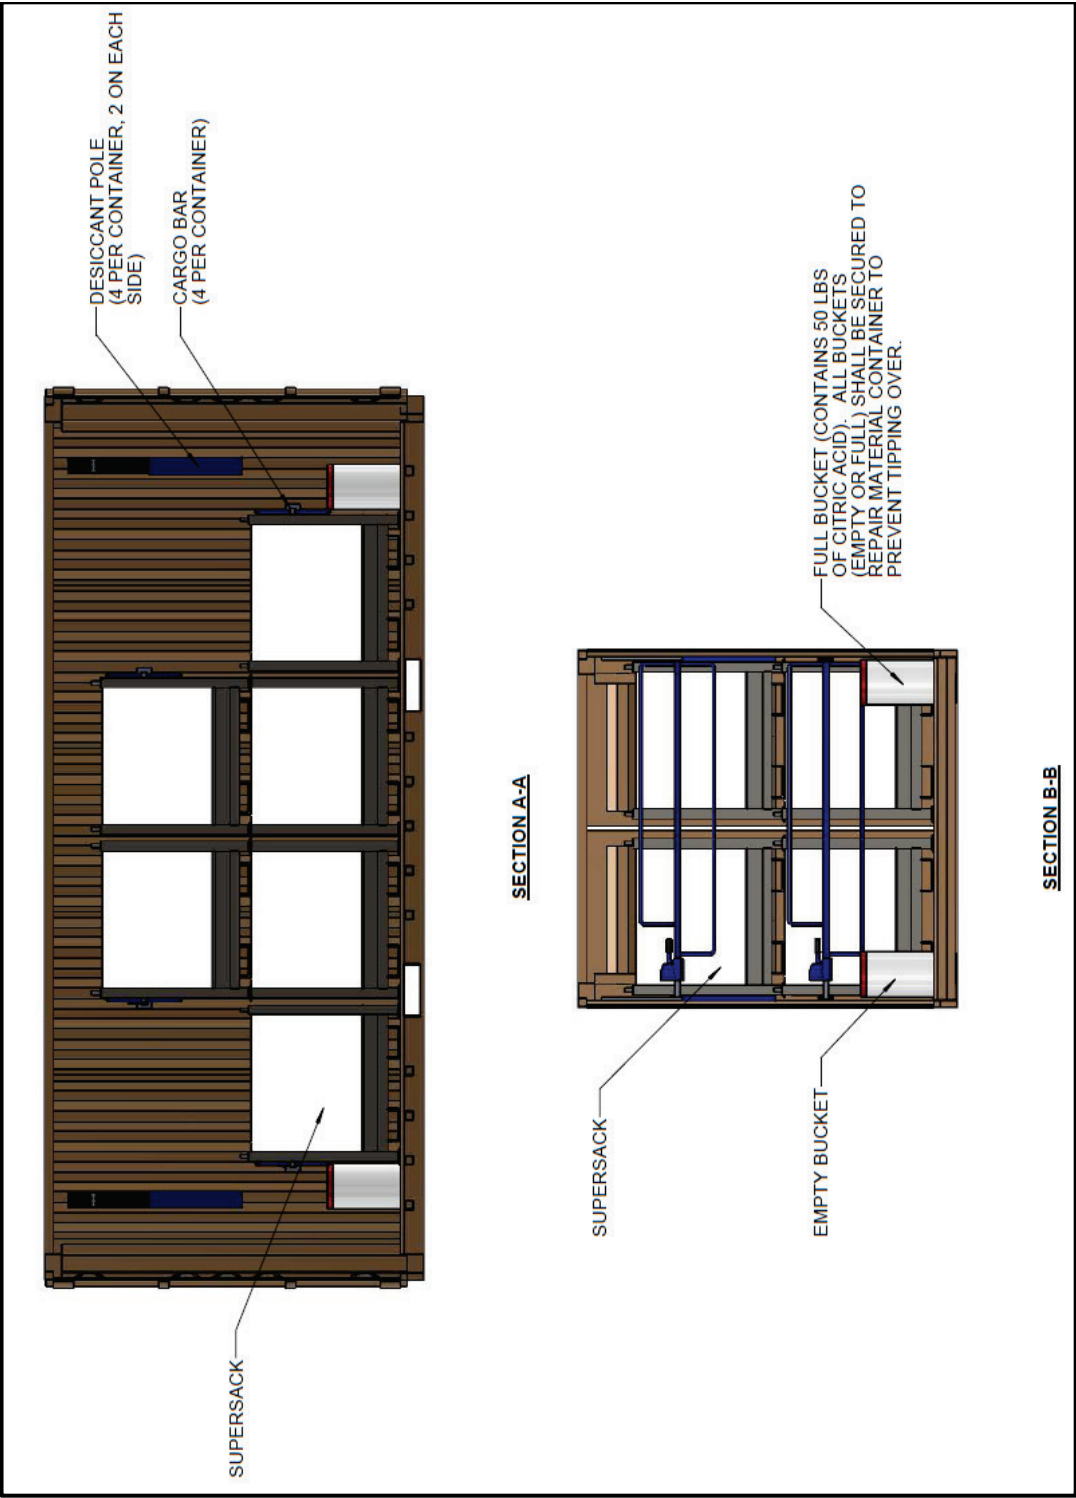
Figure A3. Material container drawing section view.
